Fence entirely made of iron with reinforced structure treated with Ferrus, a protective process that guarantees high resistance to corrosion.

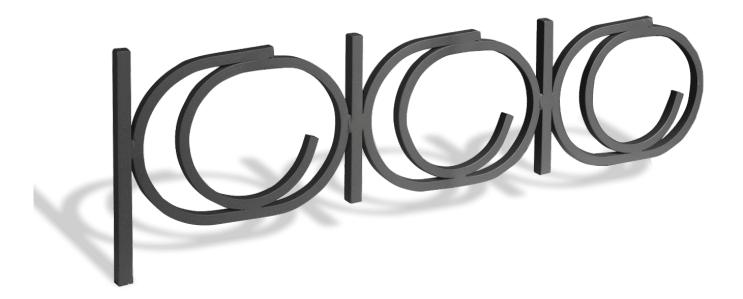
_	
Ref.	А	С	Н
VVP004	1115	375	520

The Ferrus treatment consists of three layers applied after shot cleaning all impurities: an electrolytic bath, an epoxy coating and a forge black polyester paint coating.

Recommended anchoring: concrete foundation.
