Fence made of steel treated with Ferrus, a protective process that guarantees high resistance to corrosion.

Ref.	A	H	H1
VVBA210	1790	1195	200

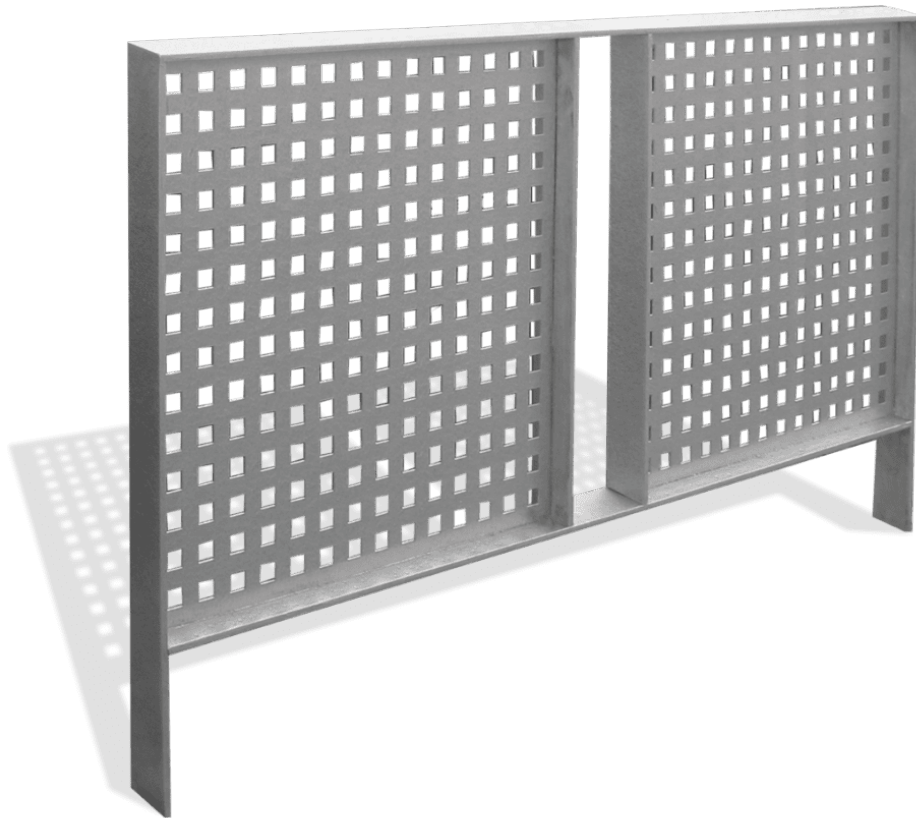
The Ferrus treatment consists of three layers applied after shot cleaning all impurities and an electrolytic bath, and an epoxy and silver grey RAL 9006 polyester paint coating.
Recommended anchoring: concrete foundation.
